Committee of the Whole  
November 12, 2025  
10:00 a.m.

## **Hamlet of Lavoy – Utility Asset Management Plan**

Date: October 3, 2025  
Project No. 5265-001-00

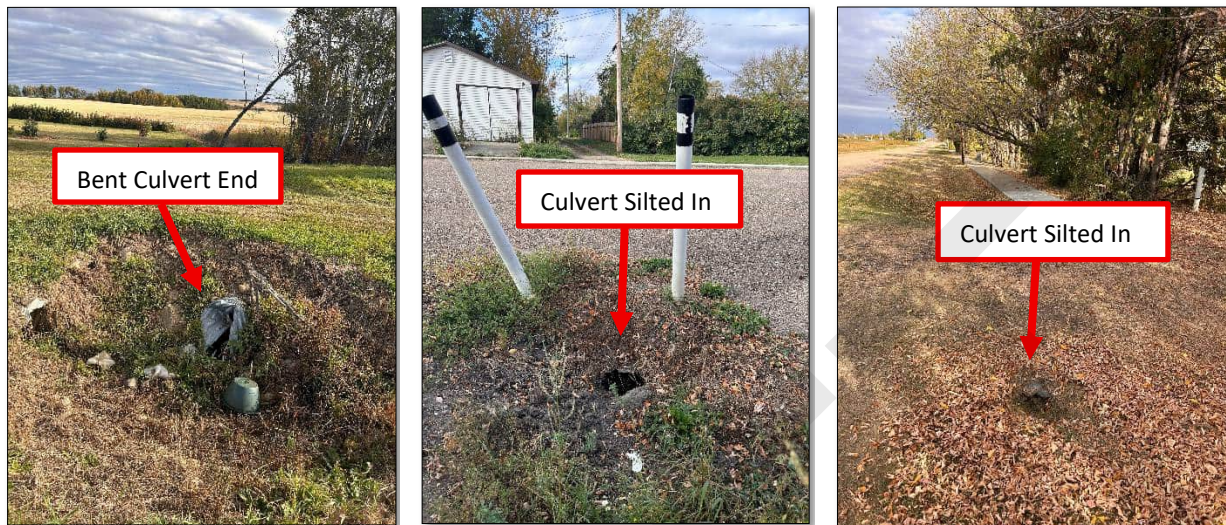
**Figure 2.1: Stormwater Infrastructure: Visual Inspections**

MPE completed a field survey of the existing stormwater infrastructure within the Hamlet of Lavoy. In general, the existing stormwater culverts appear in fair condition; however, along with the ditches, they are severely silted in and overgrown. Currently, most of the stormwater system is functioning highly under capacity, and areas are experiencing surcharging and localized flooding. Several residents expressed concern to MPE during our site inspection.

The existing CBs are constructed of metal grates placed over top of shallow culverts. All CBs except one are silted in and are not operating at full capacity. Due to the limited depth of the bury, it is not possible to install standard CBs with sumps. MPE recommends that all CBs be cleaned and then regularly inspected and maintained.

Many of the culverts, especially those along 50 (Railway) Avenue east of 50 (Main) Street, are clogged with debris or have silted-in ends. Some culvert ends are damaged, again reducing capacity. MPE recommends cleaning all culverts and then conducting a thorough inspection to determine more accurate conditions. Regular inspections and maintenance will alleviate surcharging and localized flooding.

Of primary concern is the flooding issue at 4924-52 Avenue. Water draining from west of this residence cannot properly drain due to restrictions downstream. The residents at this location have experienced flooding in the yard and garden area. Our observations indicate that two culverts are blocked at 4912-52 Avenue, and the ditch heading east is clogged with silt. MPE recommends the replacement of the two culverts and cleaning the ditch. It would be advisable to survey this area, as the elevations of the culverts and ditch may need to be adjusted to ensure the area drains properly.

It is also recommended to remove any trees and clean or re-grade all ditches within the Hamlet. Erosion matting and grass seed should be placed where topsoil is exposed to prevent premature siltation. Installing rip-rap on the ends of the larger culverts (400mm or larger) would help protect the ends. The extent of the siltation would have occurred over a long period, so once the ditches are cleaned, it would not be expected to repeat the process annually. MPE would recommend that an inspection be conducted after the spring thaw and prior to freeze-up. Clearing debris and silt around culverts and catchbasins as it builds up will prevent downstream siltation and maintenance costs.

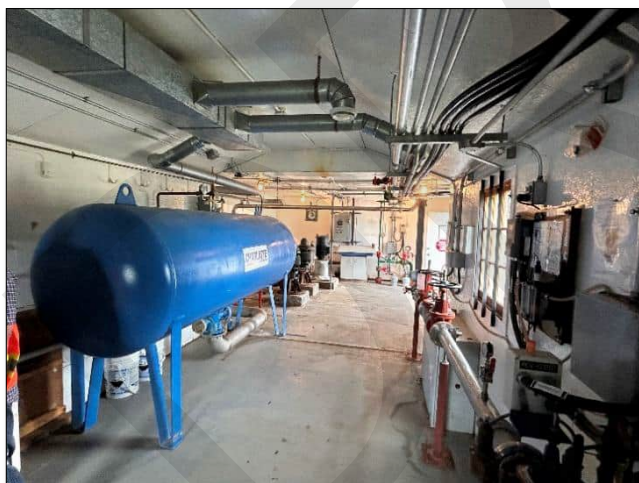
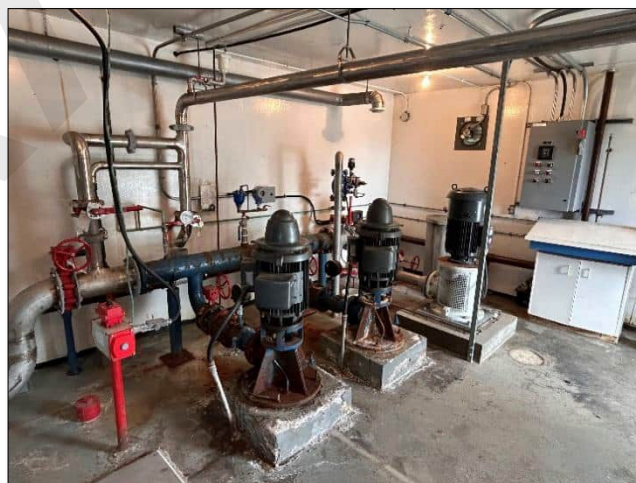
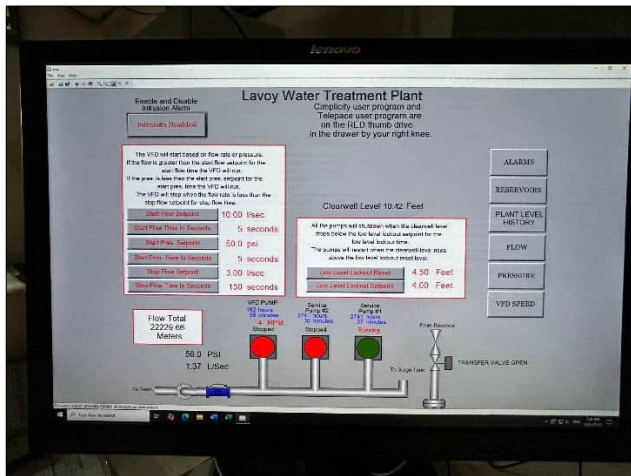
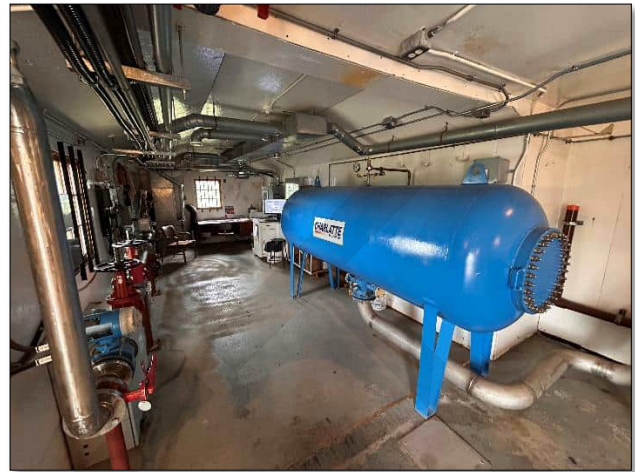
**Figure 2.2: Pumphouse Interior**

The mechanical system of the pump station is in satisfactory condition, with regular maintenance and necessary upgrades having been carried out. A new backup generator has been installed recently to ensure that the station continues to operate efficiently in the event of a power outage. Additionally, the Supervisory Control and Data Acquisition (SCADA) system, managed by a new PLC/HMI, is functioning well and is not expected to require any immediate upgrades. The system is performing as intended, and no immediate action is required. NCGL Construction, which currently provides maintenance services for the SCADA system, should perform regular reviews in accordance with its recommended intervals.

In September 2025, QQR Mechanical completed a significant upgrade by replacing outdated valves and replacing the distribution header with stainless steel piping. This work contributed to the overall improvement of the pump station's infrastructure.

MPE noted that the vertical turbines in the pump station were aging and recommended the County monitor their performance and plan for replacement in the near future. Additionally, some galvanized piping remains in the system and should be replaced with upgraded piping to ensure long-term reliability and efficiency.

- Given that QQR Mechanical is already familiar with the pump station, it is recommended that they conduct a comprehensive review of the mechanical system. This review should include:
  - An assessment of the vertical turbines.
  - A long-term upgrade and a detailed maintenance schedule.
  - A cost estimate for the inspection and future upgrades for budget planning.
- NCGL Construction, which currently provides maintenance service for the SCADA system, should perform regular reviews in accordance with its recommended intervals.
- It is recommended that the concrete underground water reservoir undergo a full inspection to assess its condition. The estimated cost for this inspection is approximately \$11,000, with an additional \$2,500 required for excavation and backfill work.

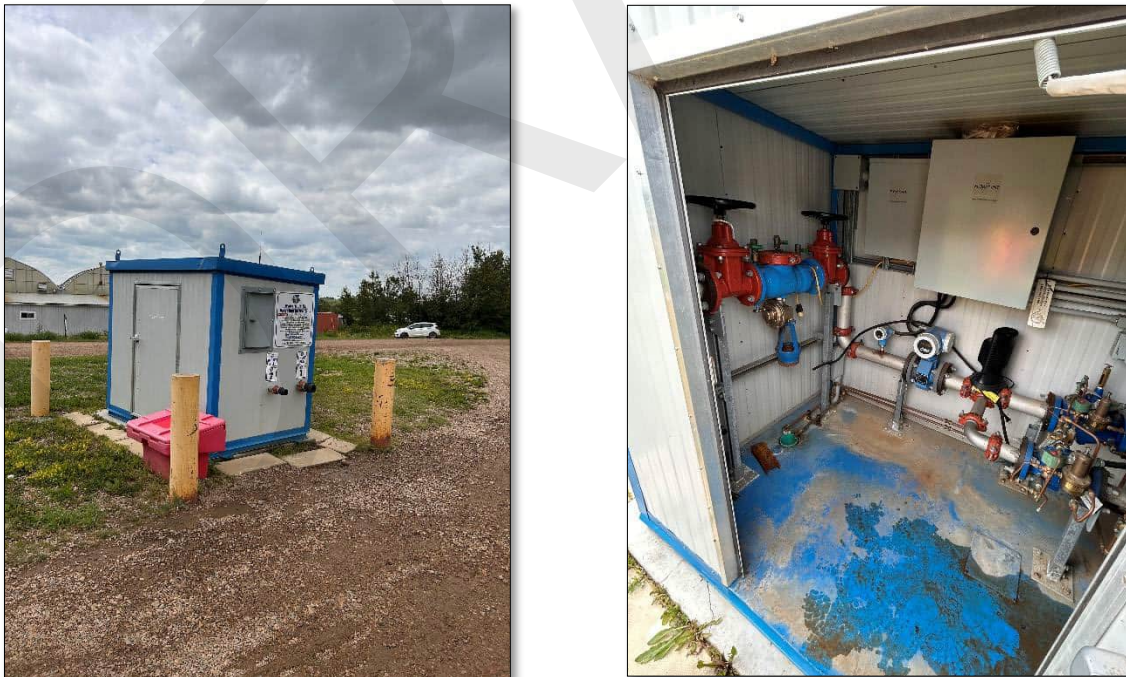
**Figure 2.3: Bulk Water Distribution Station**

Based on MPE’s inspection and information provided by the County, the bulk water station is currently functioning well. However, Flowpoint has advised that the system’s electronic control components (PLC and HMI panel) are now at the end of their life and are no longer supported. In the event of failure, these components will need to be replaced with current models. The estimated cost for replacement, including installation and calibration, is approximately \$15,000.

Flowpoint also indicated that the two singer valves within the station require seal kit replacements every 10 years. No maintenance records were found to confirm whether this work has been completed since it was first installed in 2012. Flowpoint also noted that the backflow preventor must be inspected and recertified annually. MPE recommends that the County verify whether the most recent inspection of the backflow preventor has been conducted. Flowpoint estimates the annual cost for this service at approximately \$2,000.

After review, Flowpoint and MPE estimate that the system has a remaining service life of approximately six years, with full replacement anticipated around 2032.

- Initiate annual maintenance inspections and ensure re-certification of the backflow preventor at an estimated cost of \$2,000/year.
- Allocate budget for the proactive replacement of the PLC and HMI panel at an estimated cost of \$15,000, to mitigate the risk of unexpected failure.
- Begin long-term capital planning for full system replacement in 2032. A cost estimate should be developed to support this planning.

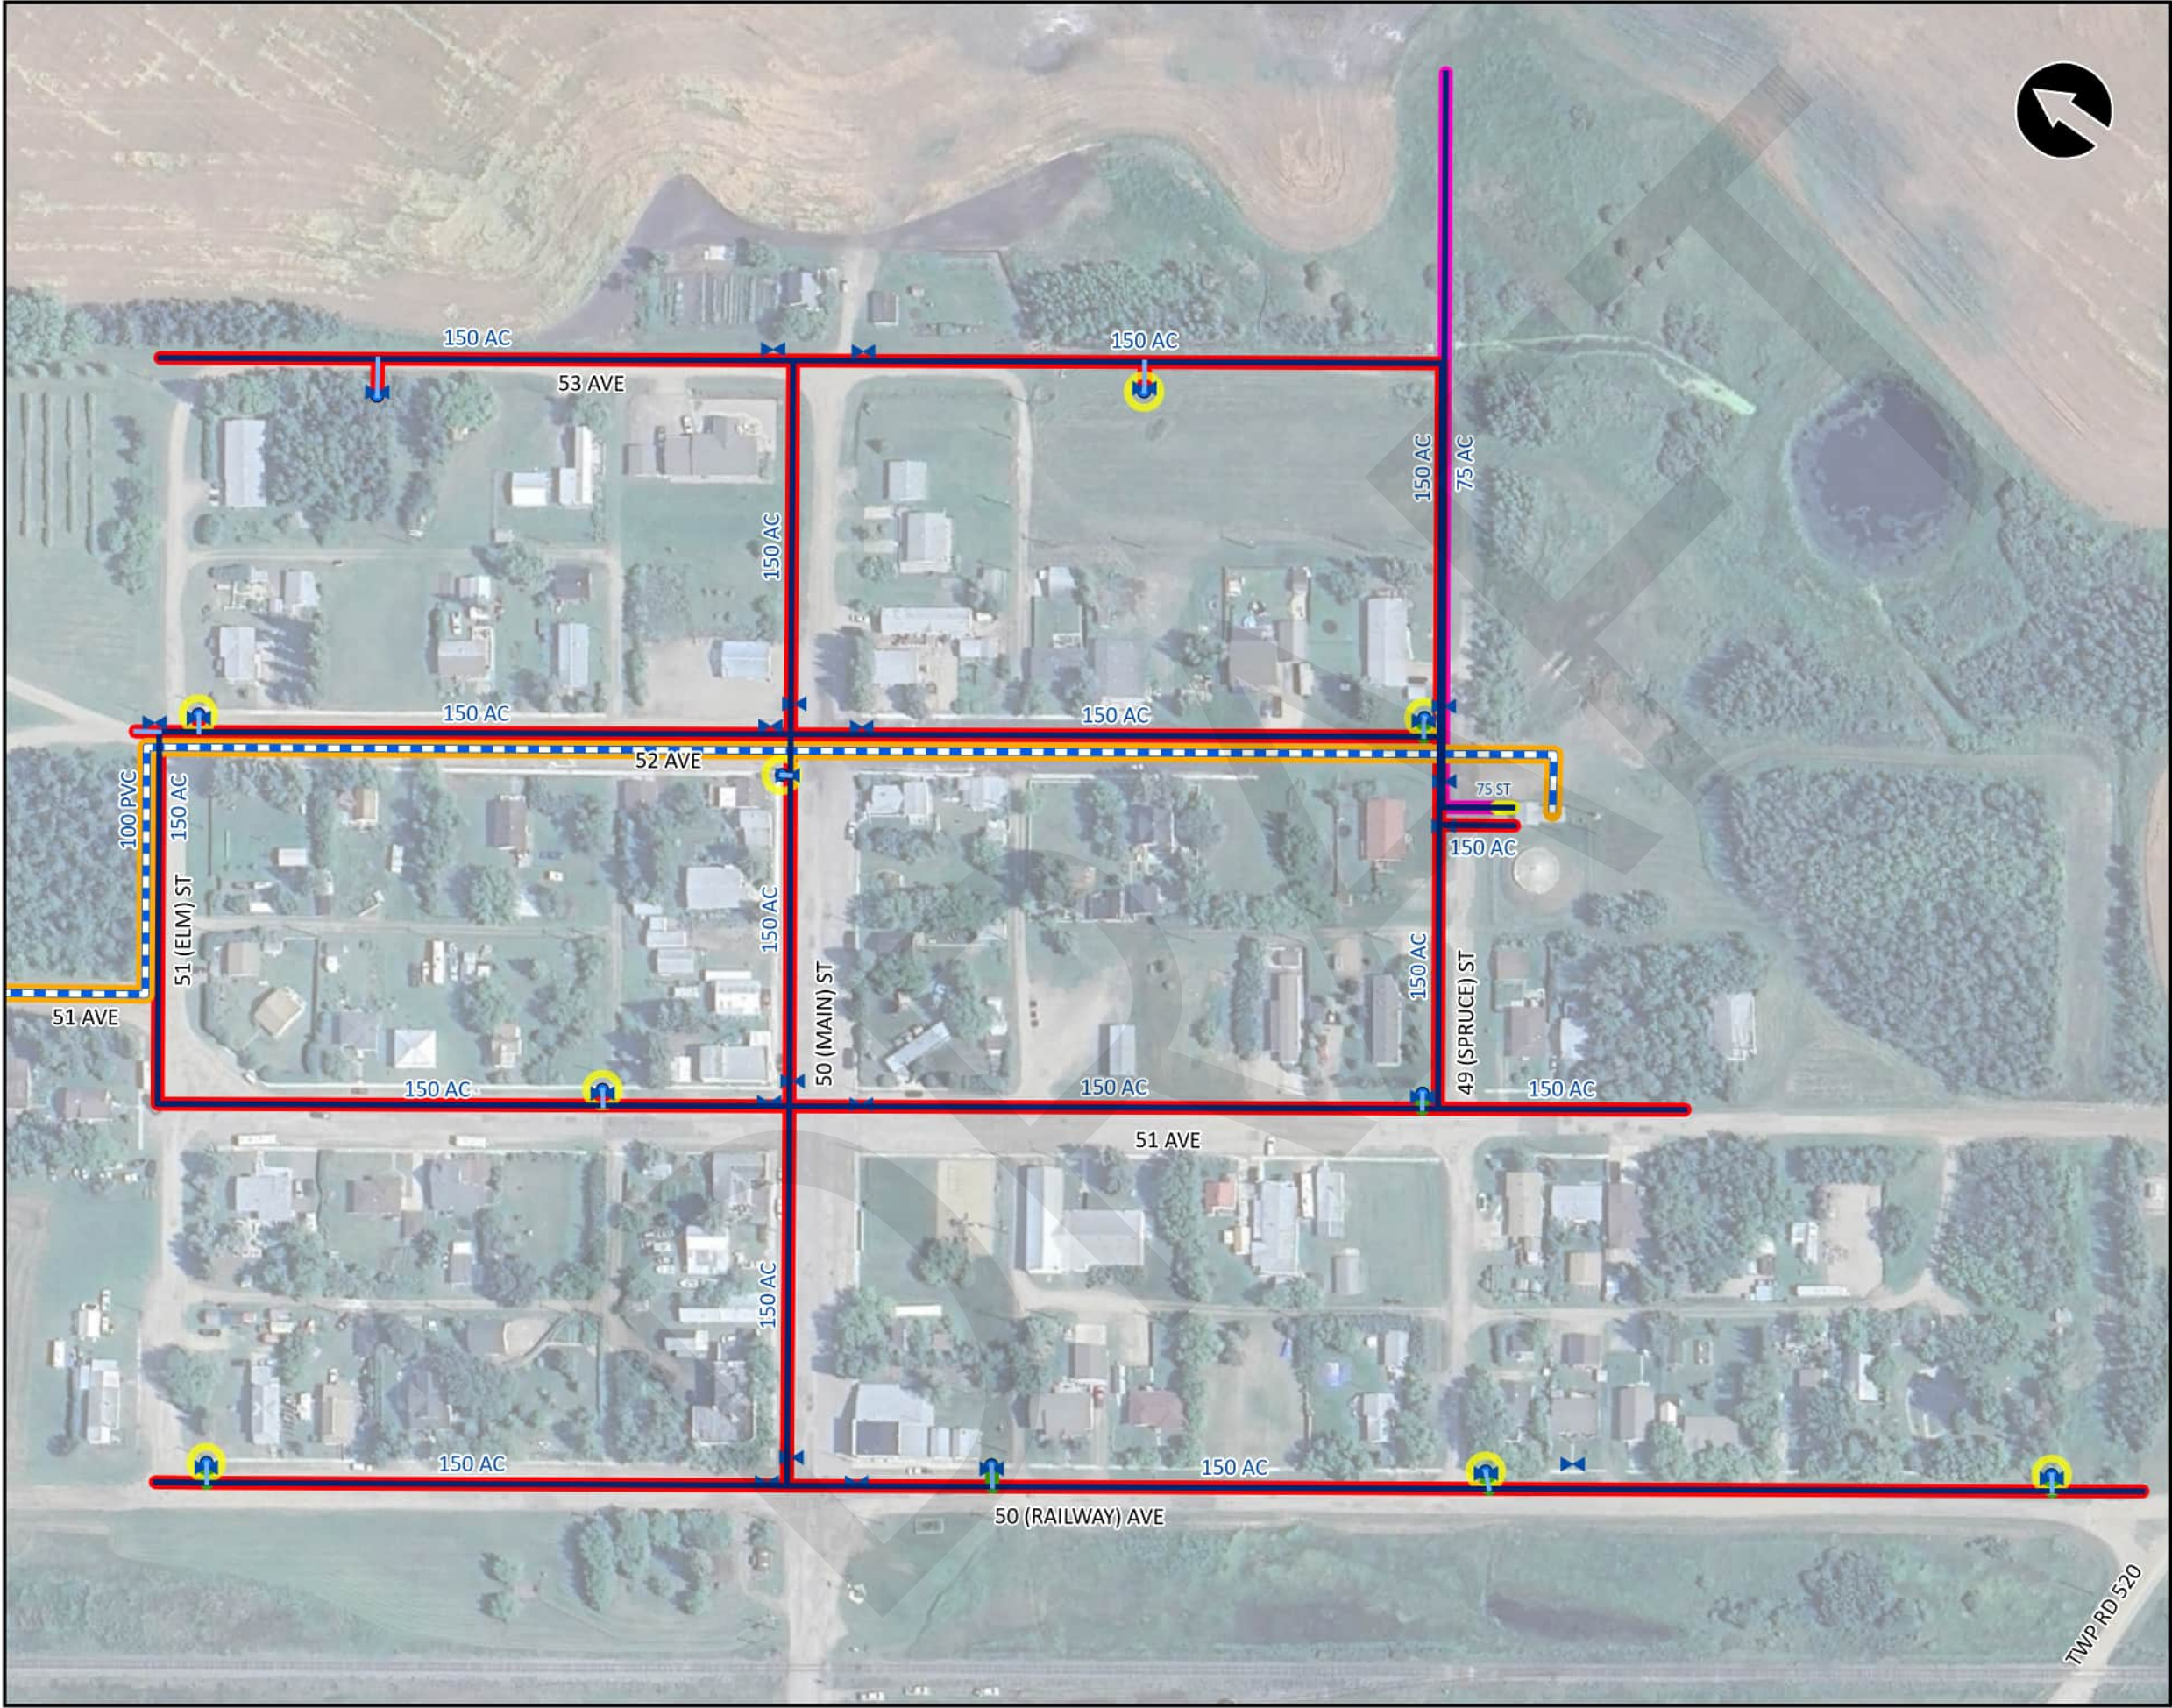
MPE has consolidated all available information regarding the existing water distribution system into **Figure 1.0 – Water Distribution System-Existing Conditions** within **Appendix A – Underground Utilities: Existing Conditions**.

The water distribution system is generally in good condition; however, aging valves and hydrants should be replaced to ensure optimal performance. The County completed an inventory of the hydrants within the Hamlet and noted the following with outstanding concerns:

MPE recommends the County prioritize the full removal and replacement of all hydrants listed above.

MPE also recommends the County prioritize the full removal and replacement of the existing AC watermain with new PVC watermain.

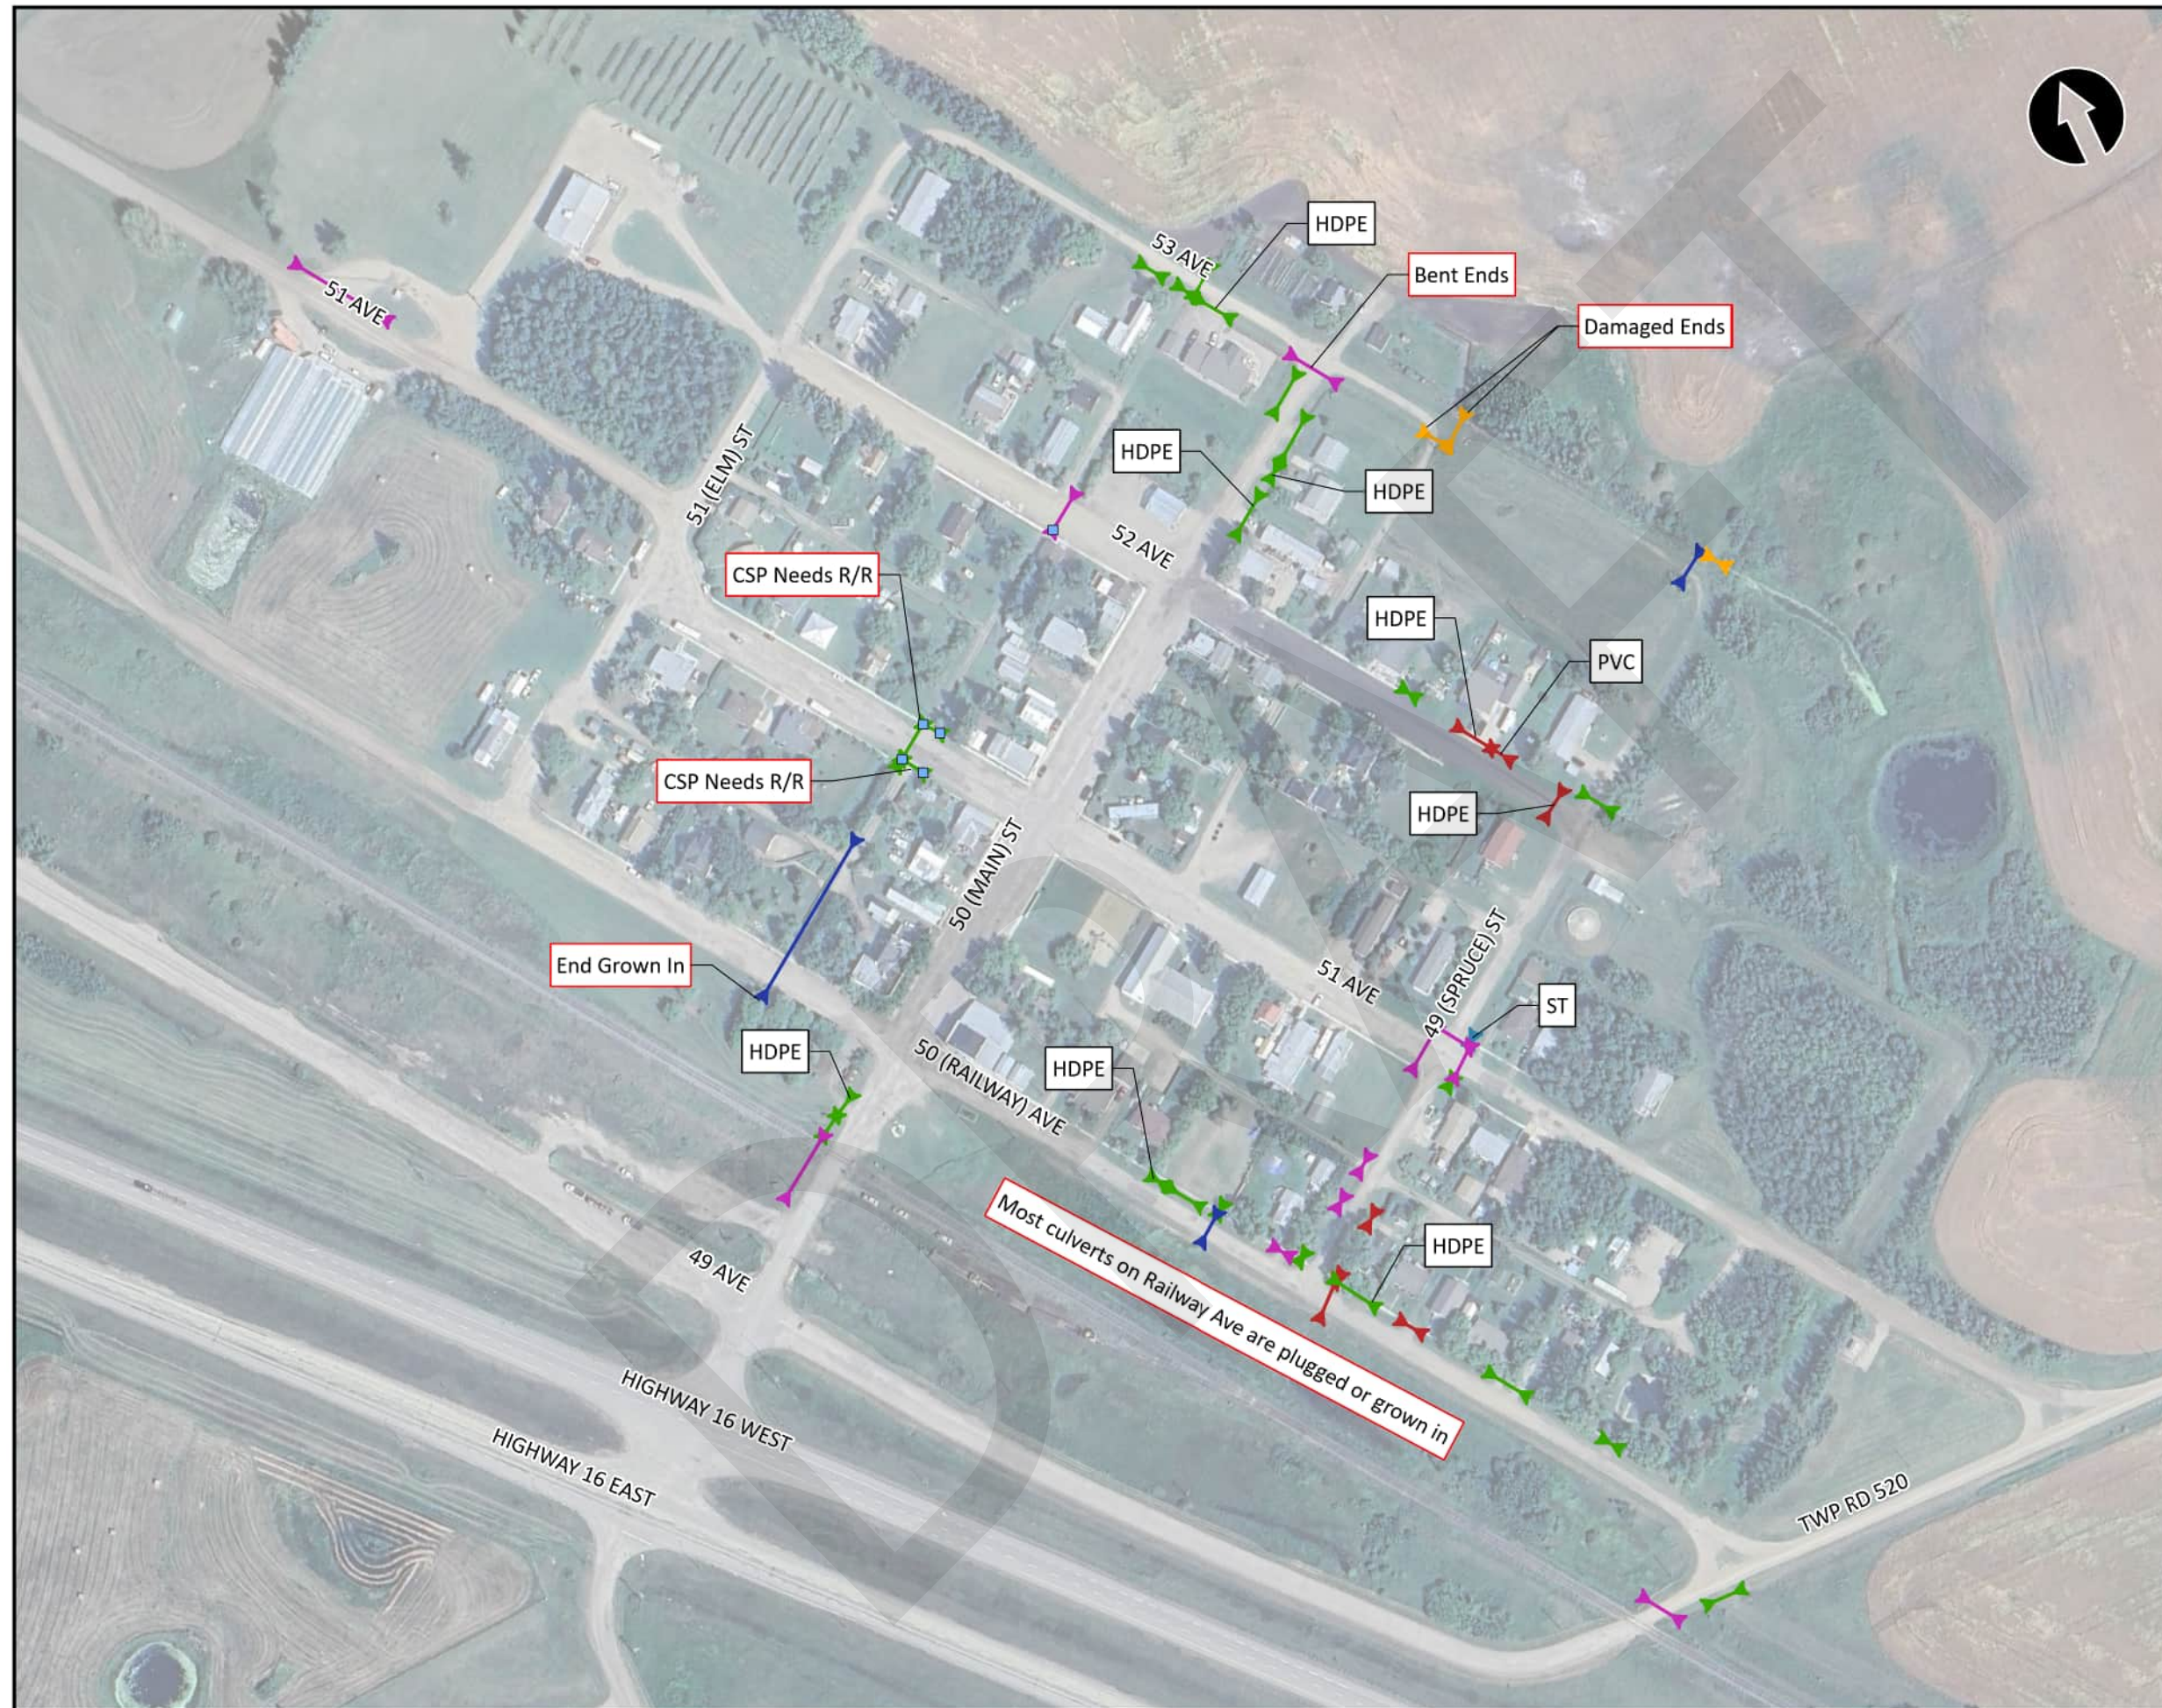
**TITLE**  
**Stormwater System - Existing Conditions**  
Asset Management Plan  
Hamlet of Lavoy

MPE has compiled all information into **Figure 3.0 – Stormwater System-Existing Conditions** within **Appendix A – Underground Utilities: Existing Conditions**. This identifies the type of material, sizes, and location of the stormwater components, as well as the existing conditions.

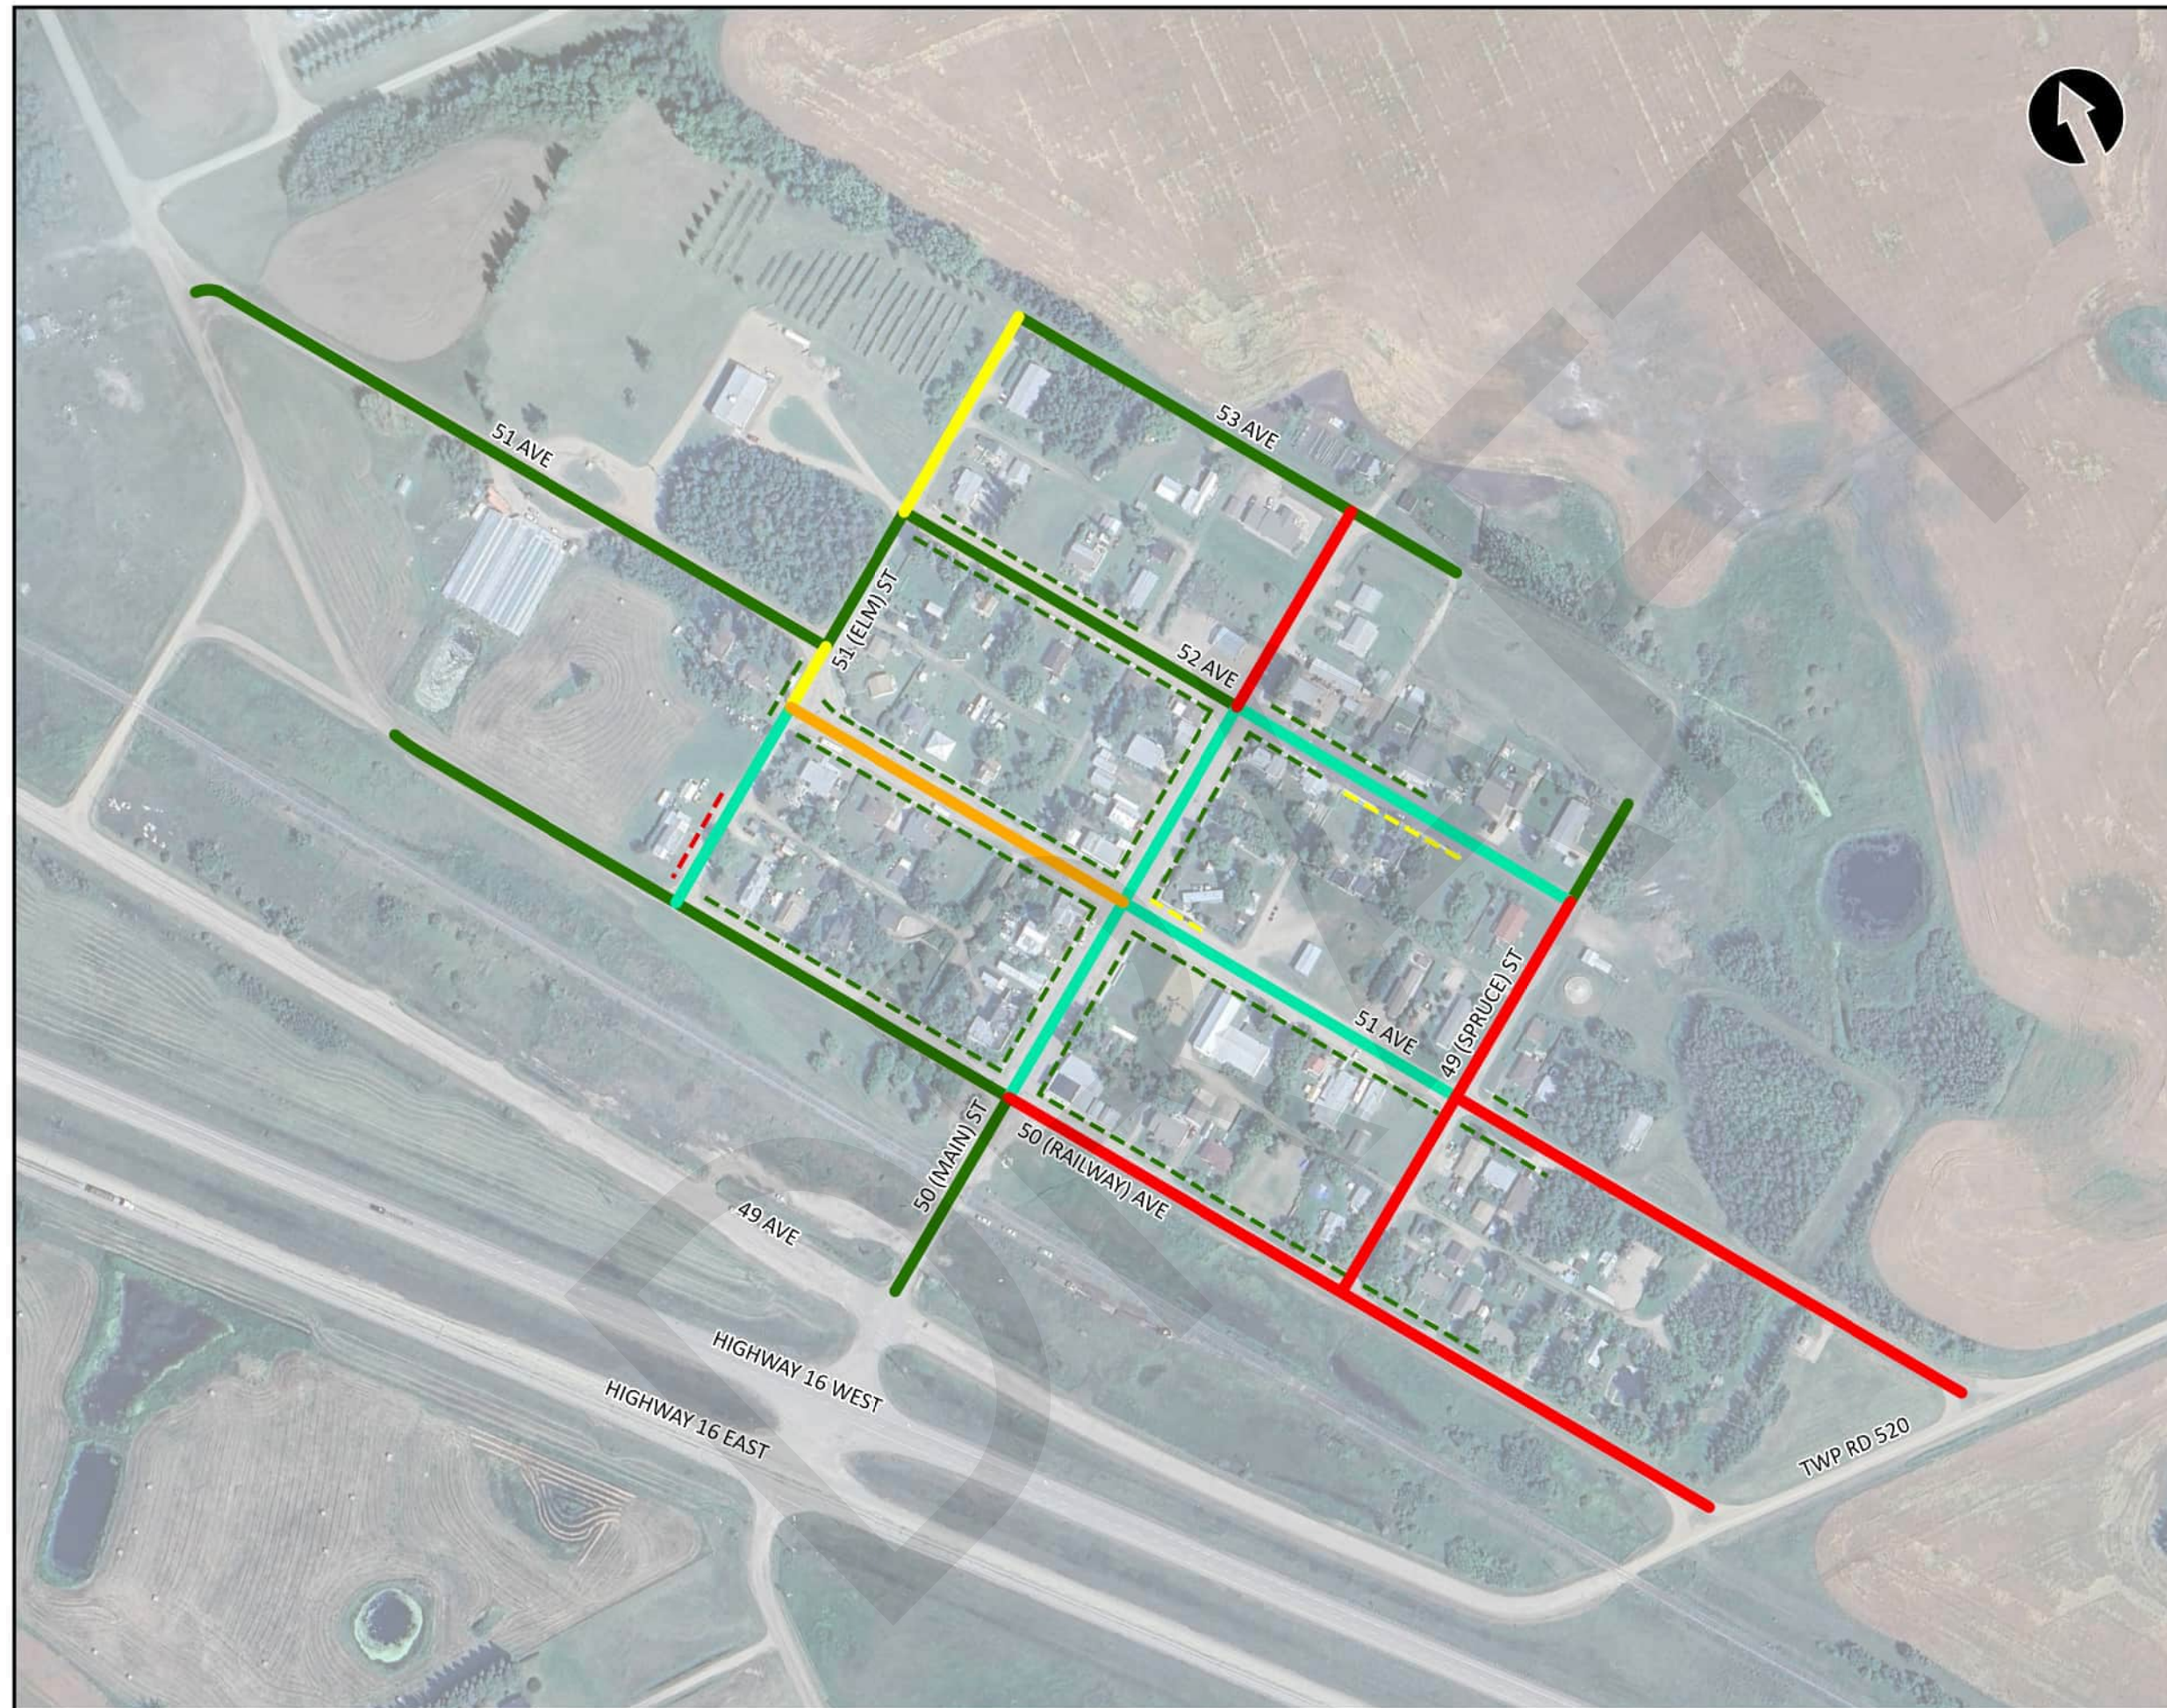
**TITLE**  
**Roads and Sidewalk - Condition Rating**  
Asset Management Plan  
Hamlet of Lavoy

The sidewalks were represented by an overall condition of Good, Fair and Poor based on the surface distress present. The field study also noted that there are currently minimal para-ramps for sidewalks within the Hamlet.
