Committee of the Whole  
November 12, 2025  
10:00 a.m.

## **Hamlet of Lavoy – Utility Asset Management Plan**

Date: October 3, 2025  
Project No. 5265-001-00

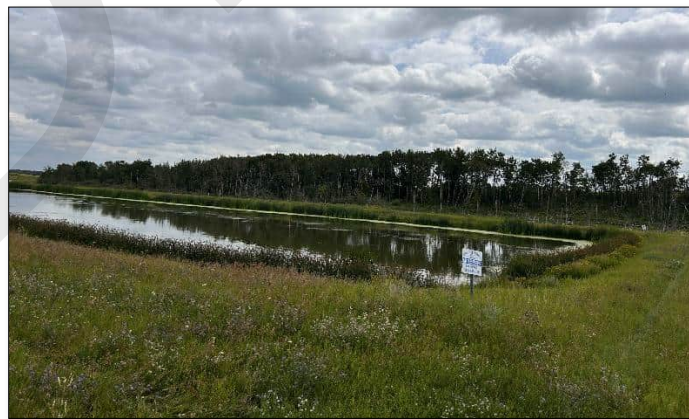
**Figure 2.4: Hamlet of Lavoy Sanitary Lagoon**

The County informed MPE that the Hamlet’s sanitary sewer system operates via a gravity-fed system and doesn't utilize sanitary lift stations with sewage-handling pumps or pressurized forcemains. The gravity sanitary sewer system feeds into the nearby lagoon located south-east of the Hamlet. **Figure 2.4 – Hamlet of Lavoy Sanitary Lagoon** shows the lagoon is fed by the hamlet of Lavoy’s gravity-fed sanitary system.

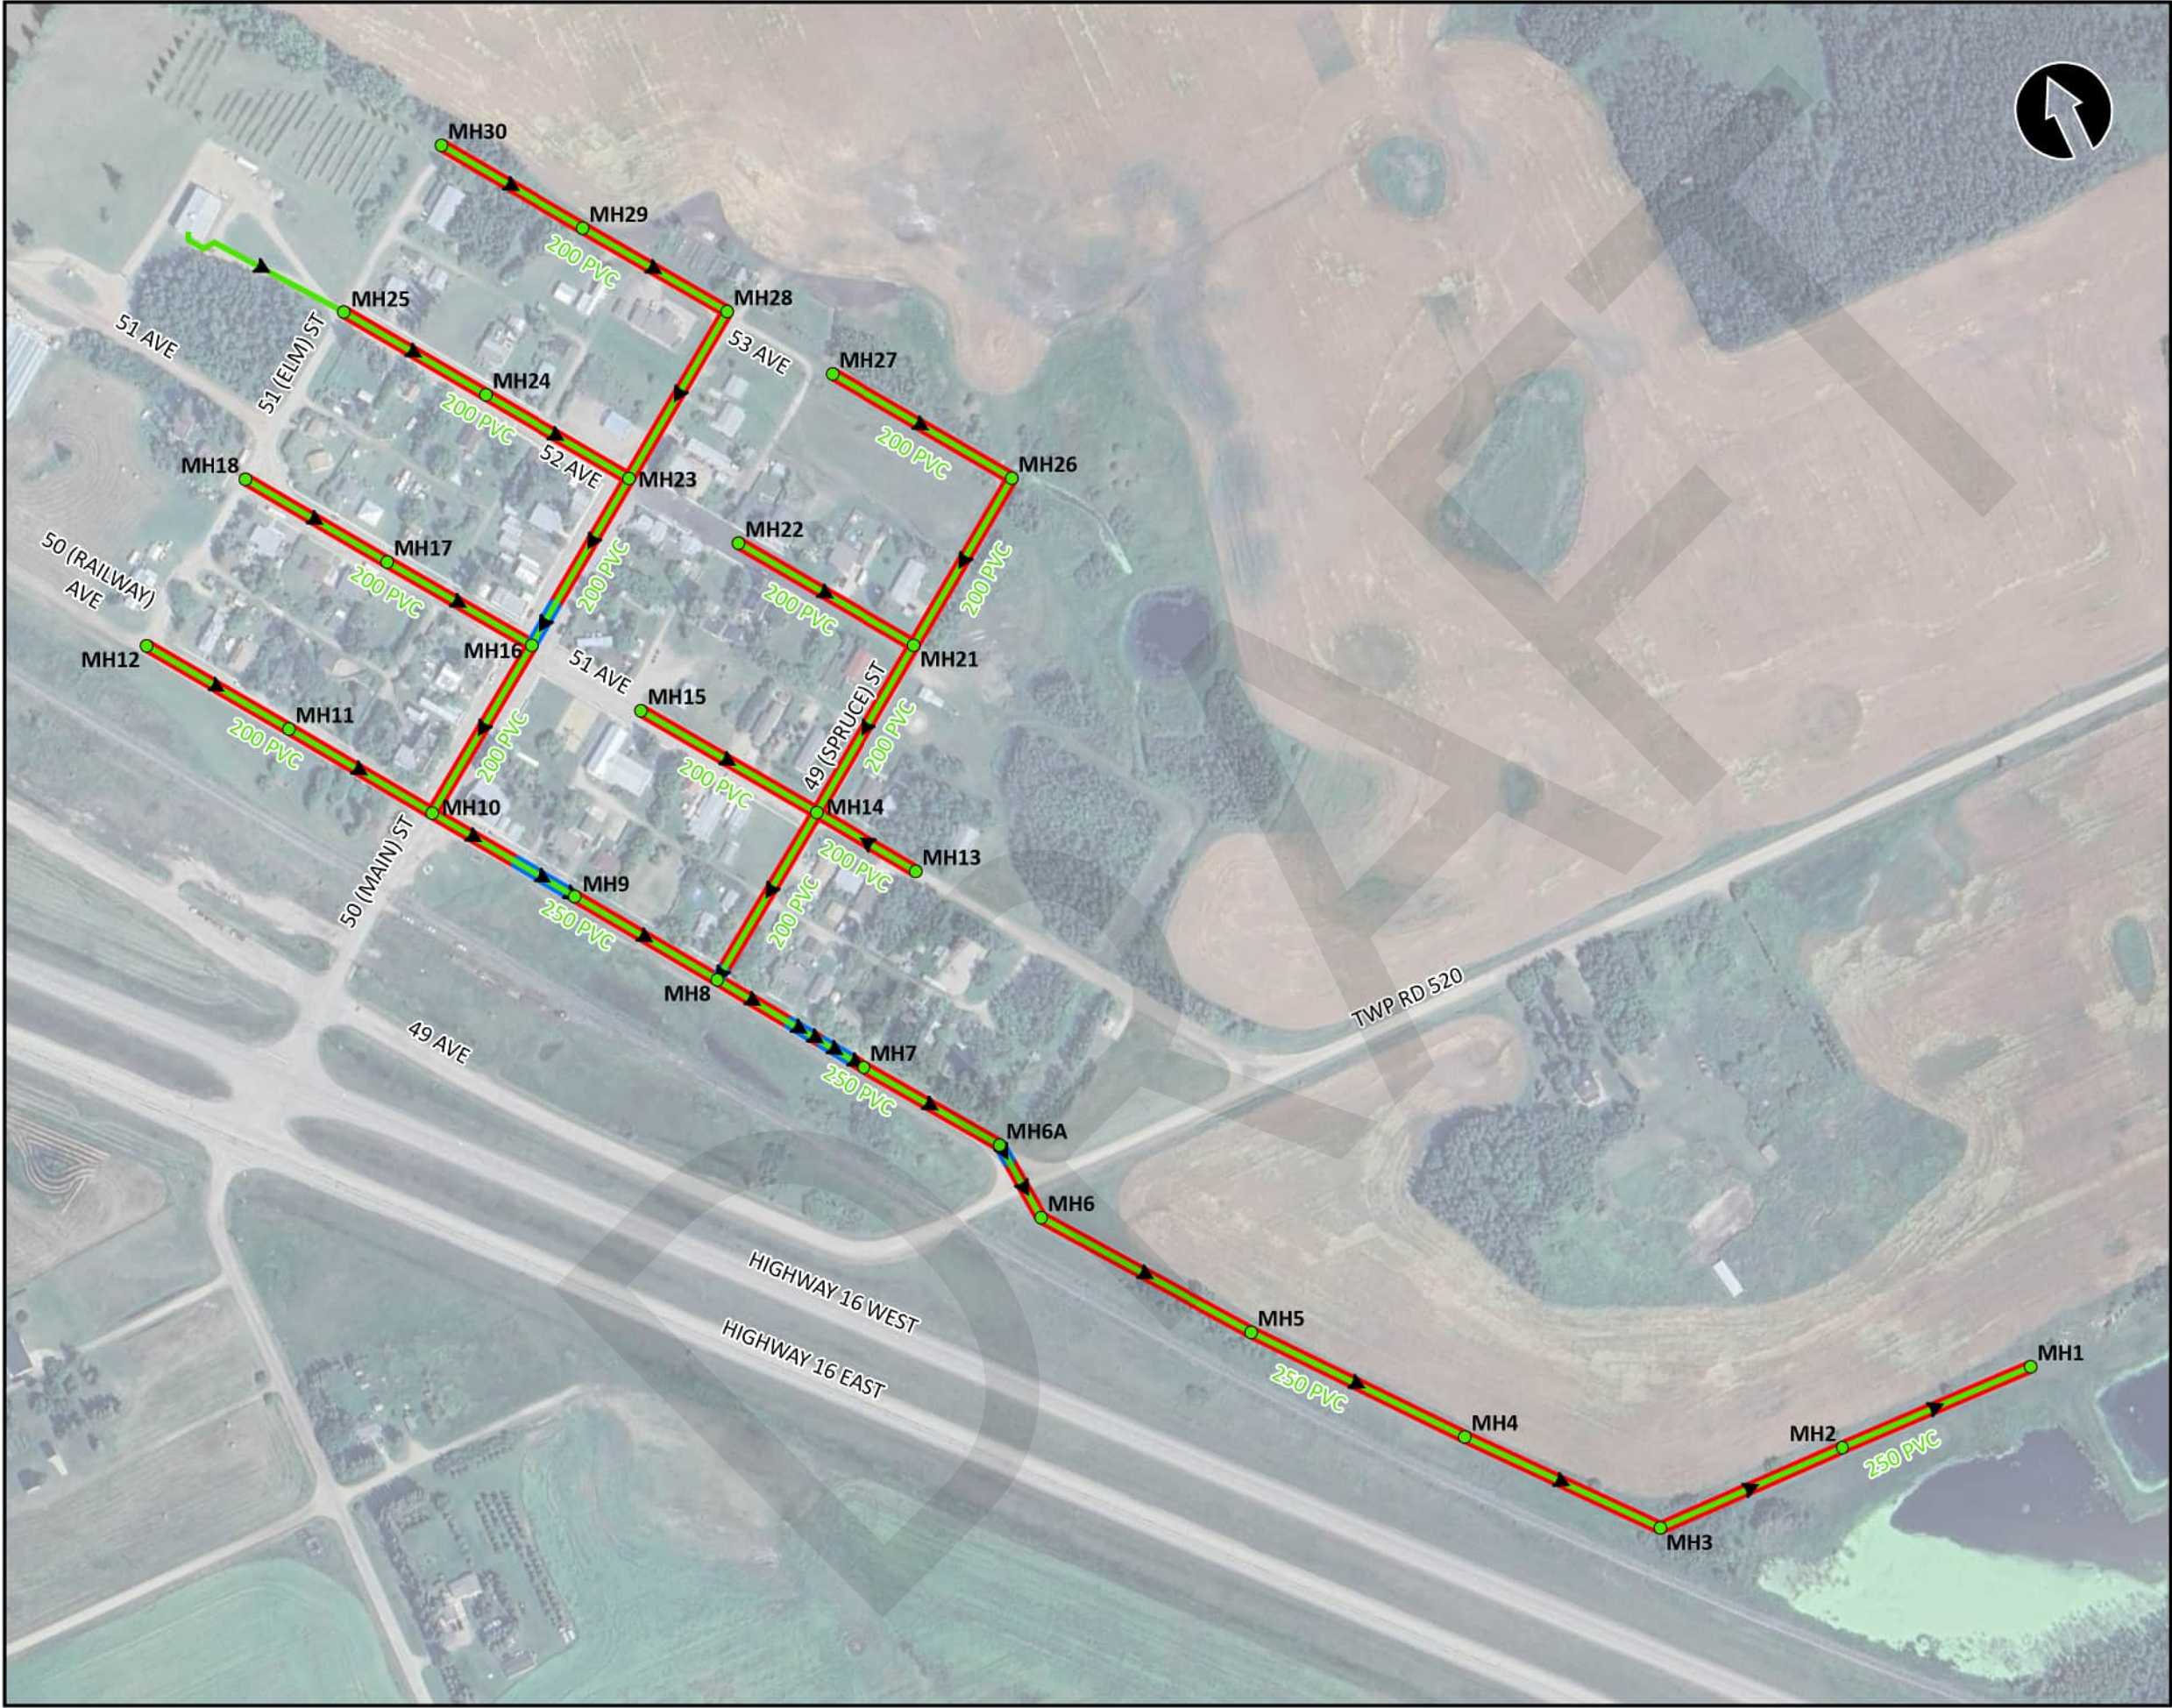
MPE has consolidated all available information regarding the existing sanitary system into **Figure 2.0 – Sanitary Collection System** within **Appendix A – Underground Utilities: Existing Conditions**. MPE recommends the County review **Figure 2.0 – Sanitary Collection System** and confirm that all information available to the County has been captured.

Following a closed-circuit television (CCTV) inspection in 2019 and subsequent select sanitary sewer repairs completed that same year, the County had an overall condition assessment of the Hamlet's sanitary sewer system completed in early 2021. Refer to **Appendix B – Previous Assessments**. The assessment was based on the 2019 CCTV inspection results and identified sanitary sections with outstanding concerns. The following have yet to be addressed:

It is recommended to inspect the sewer line between MH-10 and MH-9 with CCTV and determine if the dislodged gaskets can be removed by means of robotic equipment. If the gaskets cannot be removed remotely, then regular inspections of the upstream manhole(s) should be performed to ensure no blockages or back-ups are occurring.

The sewer line between MH-27 and MH-26 is located along 53 Avenue, which is undeveloped, and there appears to be no services connected to the line. Until development occurs along 53 Avenue, there is no need to repair the sags. This section of pipe can be televised at the time future development takes place and re-assessed to determine if the line requires spot repairs or a full replacement.

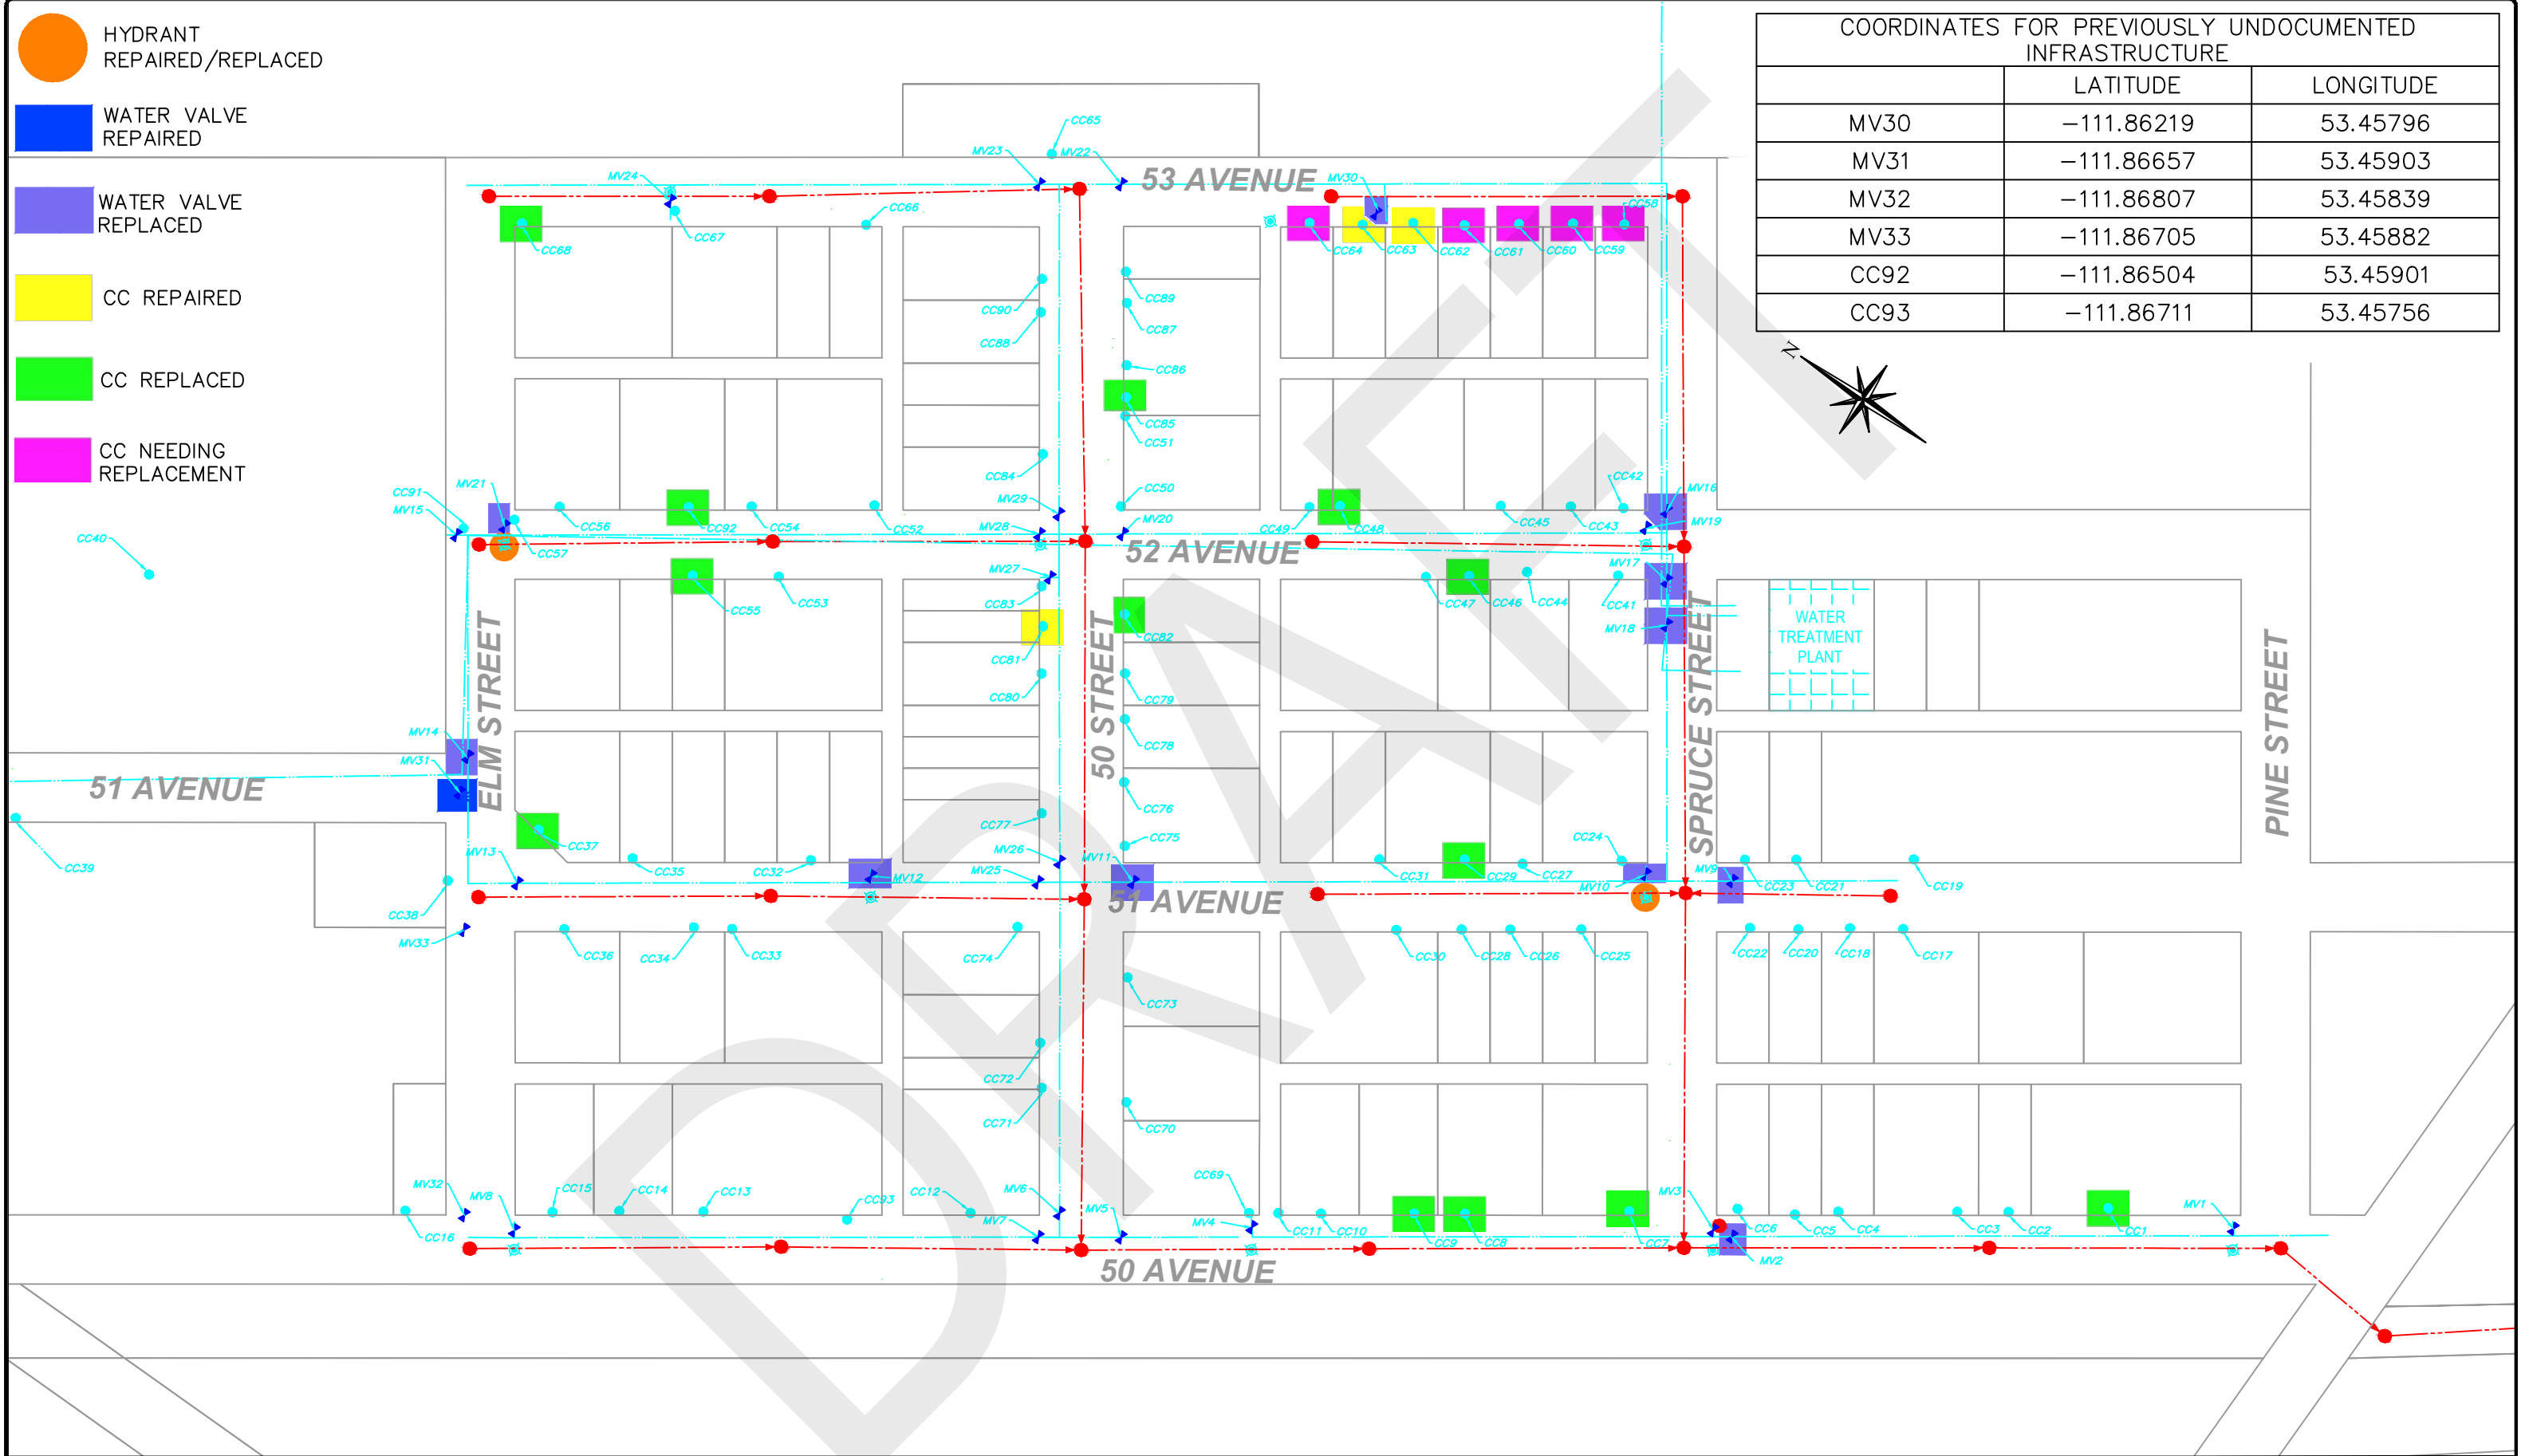
1. Repairs to CC62, CC63, and CC81 which involved the replacement of the spindle and box for the CC.
2. Total CC replacements were completed for CC1, CC7-CC9, CC29, CC37, CC46, CC48, CC55, CC68, CC82, CC85, and CC92.

It should be noted that either replacement or repair is needed on CC58-CC61, and CC64. The repairs were not completed as these CCs service empty lots. CC37 and CC68 were both relocated, leaving the old CC in its original place. CC18, CC19, CC73, CC76, and CC93 were not operating correctly, but given their location and the lots which they serviced (park space, double lot, etc.) the County indicated not to complete repairs. CC57 was unable to be located and therefore not tested. CC67 could not be located, but two (2) other CCs were found on either side of the County's documented coordinates for it, both in working order.

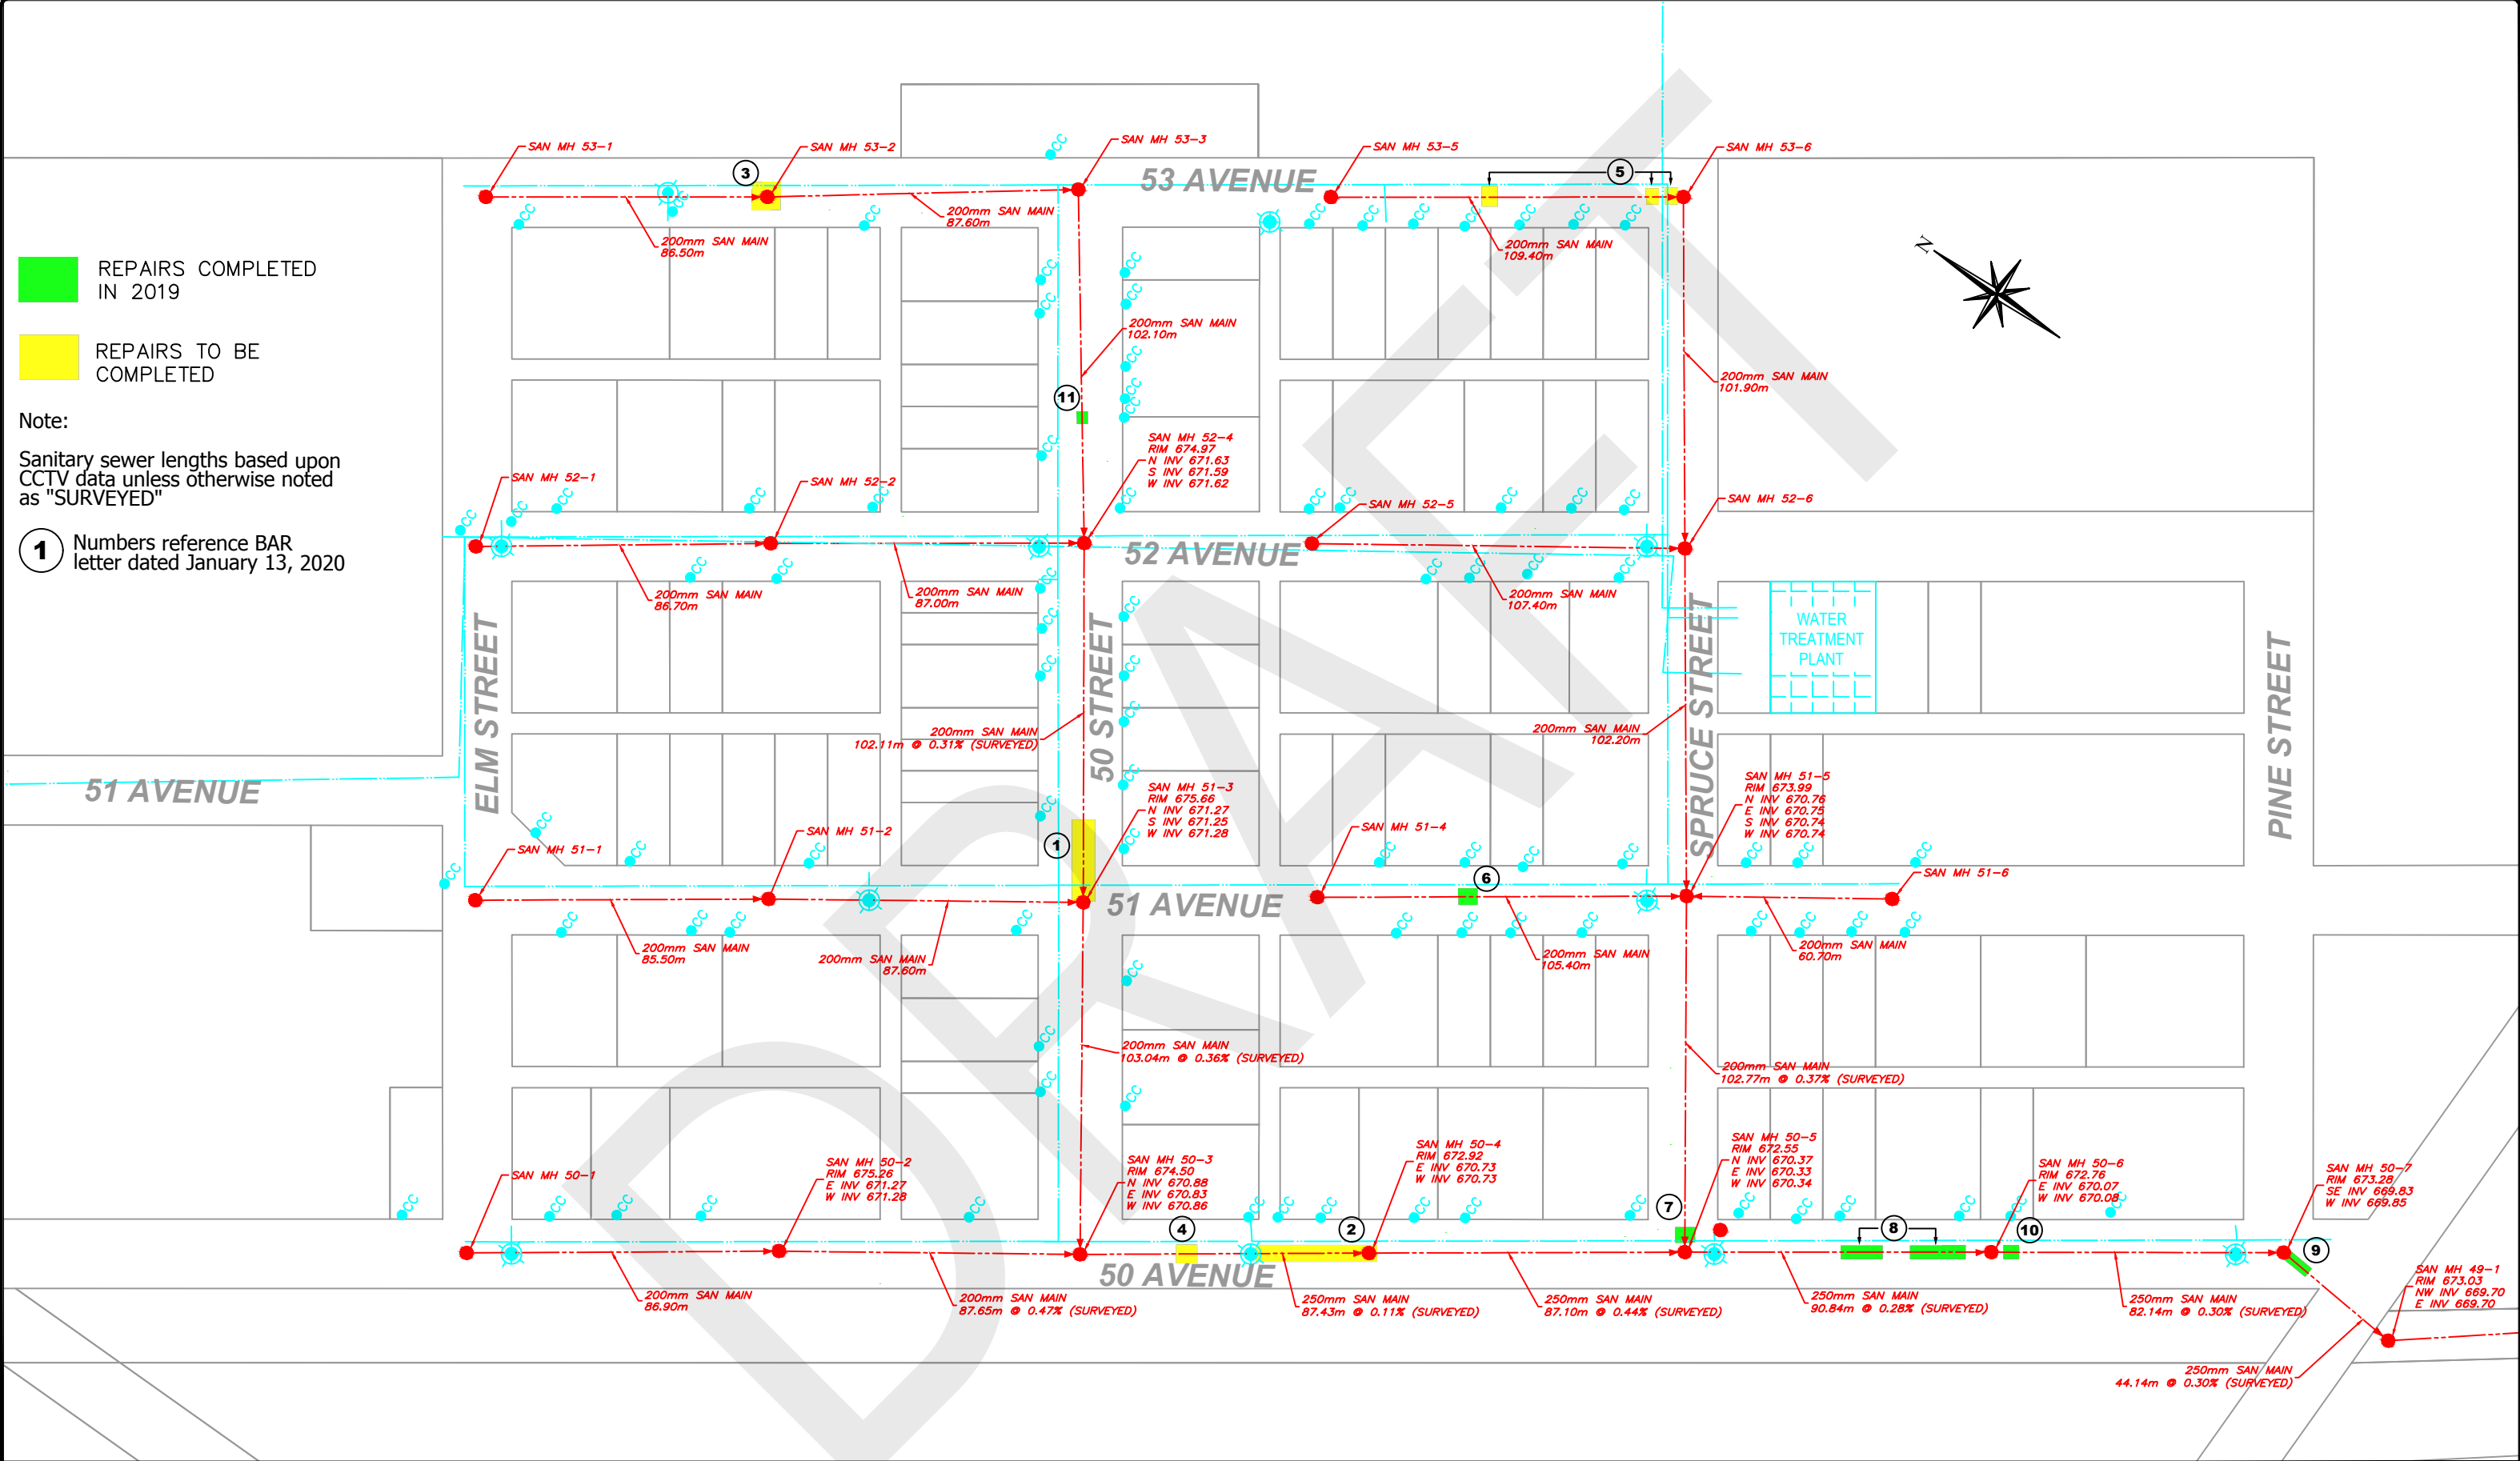
A plan is attached outlining the remaining areas of concern. Note that bulges were observed in the top half of the pipe between 52-5 and 52-6, and 51-5 and 51-6 which are not impacting flow (pipe observed to be deformed only).

Note that there were several areas of up to 20 percent full sags not identified on the summary provided above which BAR did not consider requiring repair due to flow characteristics not be severely impeded. The County has not experienced any significant historical issues in the sanitary sewer system and with a routine flushing program the impacts in these lesser sagged areas would be anticipated to have minimal effect on the system performance.

Overall the condition of the PVC pipe the sanitary sewer system is constructed of is in good shape and would be anticipated to provide the County competent performance for the foreseeable future. Relative to the original installation date of the sanitary sewer system being early 1970s (based upon discussion with County personnel), the sanitary sewer has been operating for approximately 50 years. The expected lifespan of PVC pipe is 50 to 80 years, with an average of 70 years, although some data provided by plastic pipe manufacturers indicates a possible 100+ year life for the material. One factor influencing lifespan will be the users of the system and with Lavoy being predominantly residential in nature (i.e; no significant industry or chemical exposure) the system would be anticipated to be a relatively inert environment limited to transmission of domestic waste.
